RESIDENTIAL REPORT

123 1st Street
Centralia, WA 98531

MARCH 14, 2025

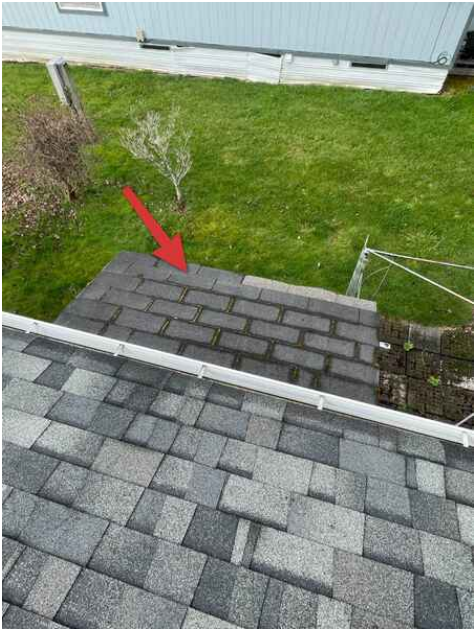
2.1.1 Coverings

LOSS OF AGGREGATE

PORCH ROOF

Asphalt shingles showed moderate loss of aggregate. Consistent with age, this reduces the effectiveness of the roofing tile and will eventually lead to failure.

This was ONLY observed on the roofs covering the front and back porch. No signs of leaking were observed, and water would not penetrate into the home if a leak was present.

Contact a qualified roofing professional.

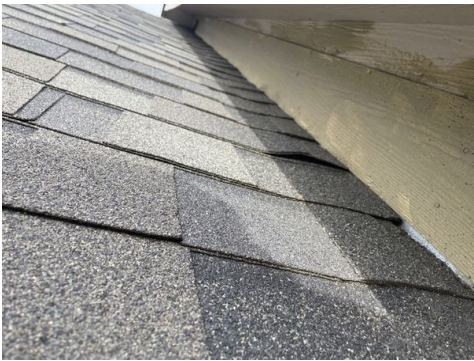
2.1.2 Coverings

SHINGLES BUCKLING- MINOR

Buckling occurred in a protected area and no sign of water damage was observed, but buckled shingles have the possibility to allow water penetration in heavy rains

Contact a qualified roofing professional.

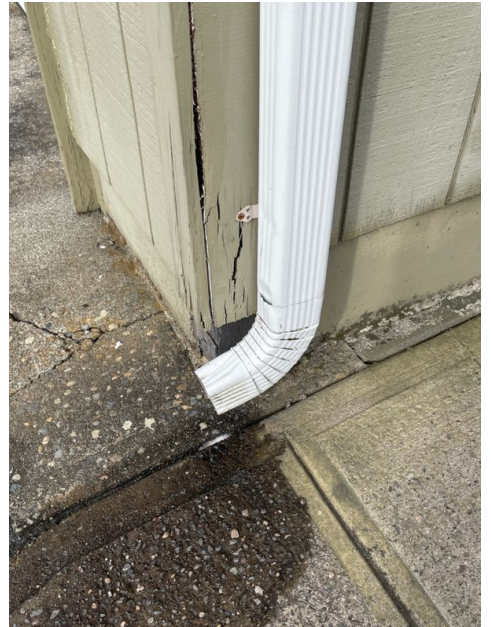
2.2.1 Roof Drainage Systems

DOWNSPOUTS DRAIN NEAR HOUSE

One or more downspouts drain too close to the home's foundation. This can result in excessive moisture in the soil at the foundation, which can lead to foundation/structural movement. Recommend a qualified contractor adjust downspout extensions to drain at least 6 feet from the foundation.

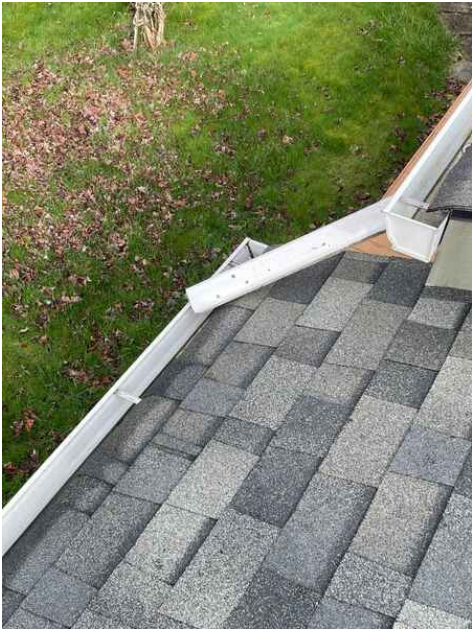
2.2.3 Roof Drainage Systems

GUTTER DISCHARGES IMPROPERLY

One or more downspouts discharge improperly. As shown in the photo, the downspout from the upper portion of the roof discharges into another gutter. This would be correct, however in this case the gutter is installed at a strange angle and one edge overshoots the lower gutter. In heavy rain this could allow water to discharge over the edge of the gutter.

Contact a qualified professional.

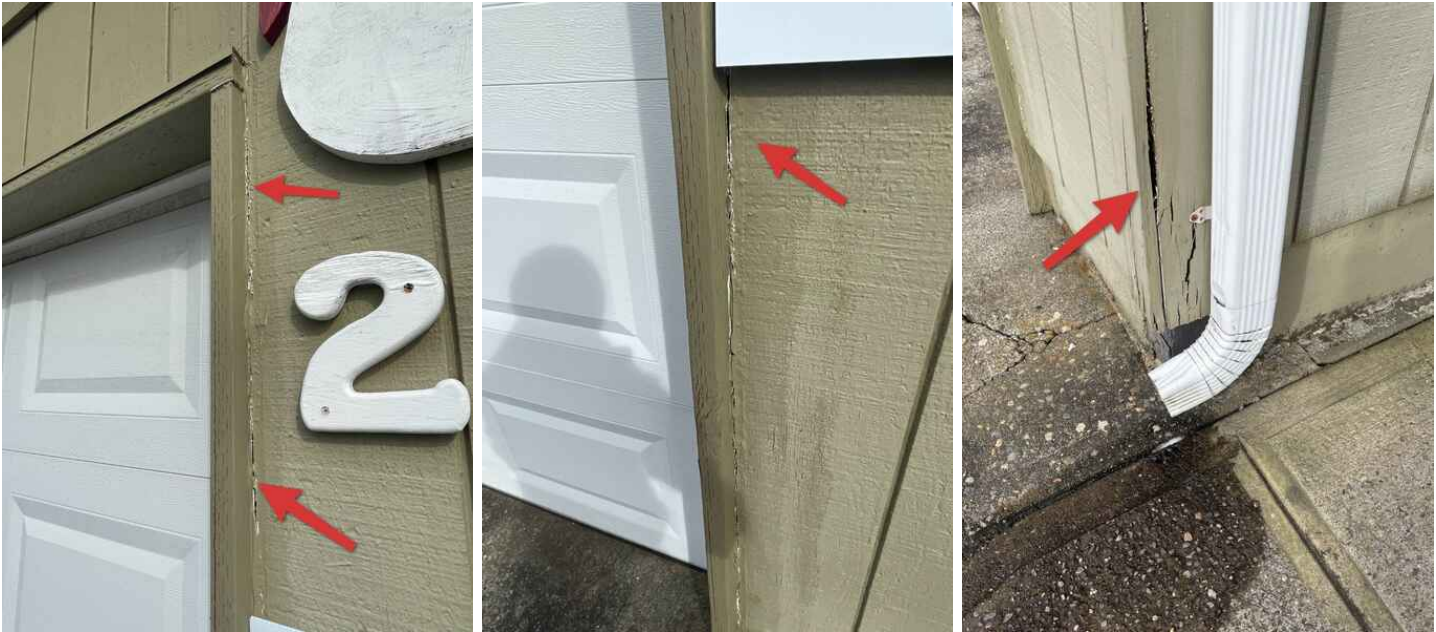
3.1.1 Siding, Flashing & Trim

TRIM NEEDS SEALING

Caulk or other sealants have failed along trim in one or more places. Gaps between siding and trim can allow water and pests to enter the building envelope. Recommend sealing with an appropriate exterior grade caulk or other sealant.

Recommendation
Contact a handyman or DIY project

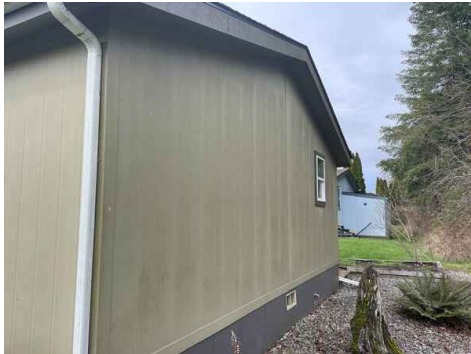
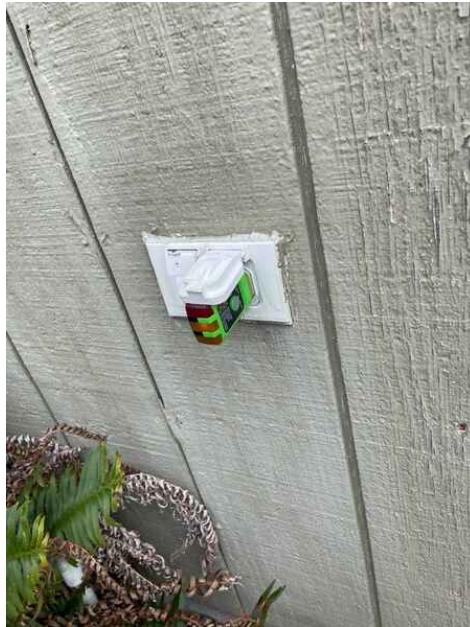
3.1.2 Siding, Flashing & Trim

WORN PAINT

Exterior paint is showing signs of wear consistent with age. No immediate action is needed, but should be kept under observation.

Contact a qualified professional.

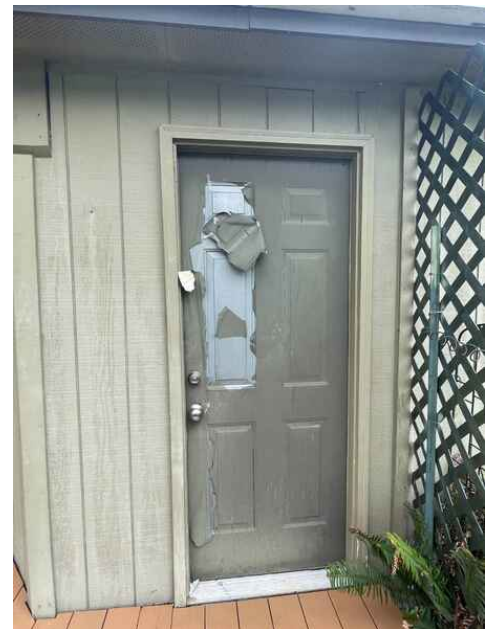
3.2.1 Exterior Doors

PAINT/REFINISH NEEDED

Door finish is worn. Recommend refinish and/or paint to maximize service life.

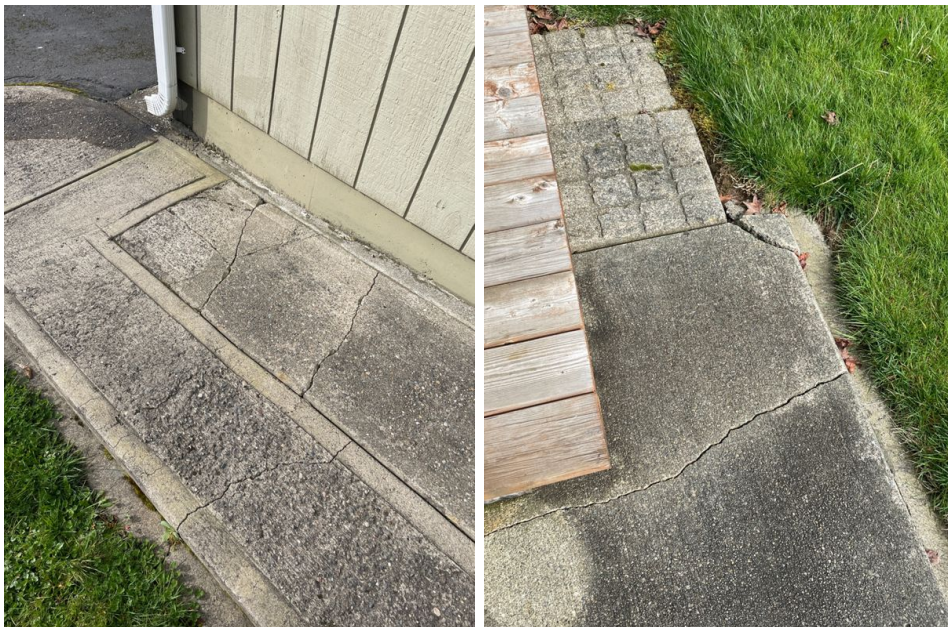
3.3.1 Walkways, Patios & Driveways

WALKWAY CRACKING - MINOR

Minor cosmetic cracks observed. Recommend monitor and/or patch/seal.

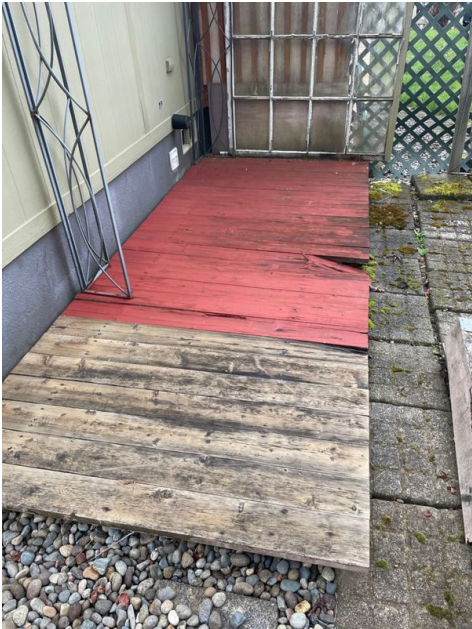
3.4.1 Decks, Balconies, Porches & Steps

DECK - ROTTED BOARDS

Deck shows significant decay, with many rotten and loose boards. Recommend removal and replacement by qualified contractor. Deck is deemed unsafe to traverse.

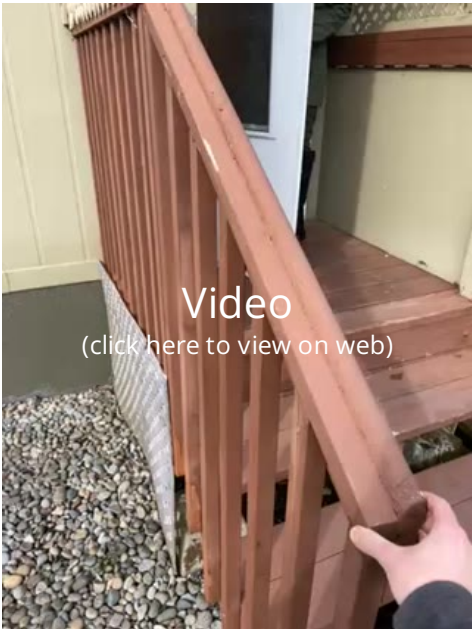
3.4.2 Decks, Balconies, Porches & Steps

RAILING NOT SECURE

Railings on both sides of the front and back porch would not support the recommended 200lbs of force. Recommend assessment by a qualified professional to secure properly.

Contact a qualified professional.

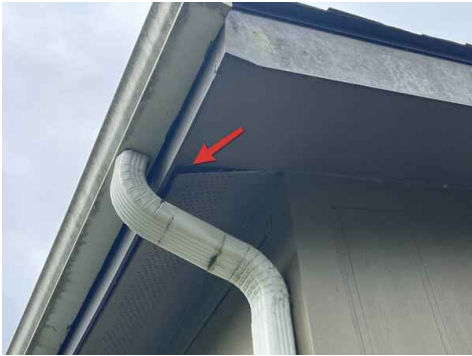
3.5.1 Eaves, Soffits & Fascia

GAP

There is an opening, gap or hole in fascia / soffit which should be repaired. This can allow water intrusion and rodent infestation as well as deterioration of the surrounding material.

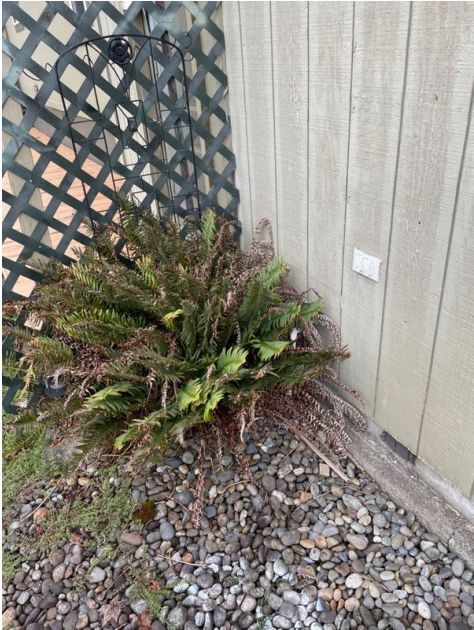
3.6.1 Vegetation, Grading, Drainage & Retaining Walls

VEGETATION NEAR THE HOME

There was vegetation near the home. This can lead to deterioration of the wall cladding. This is also a limitation to the exterior of our inspection. Recommend that the vegetation be cut back to at least 6inchs from the home.

Recommendation
Contact a handyman or DIY project

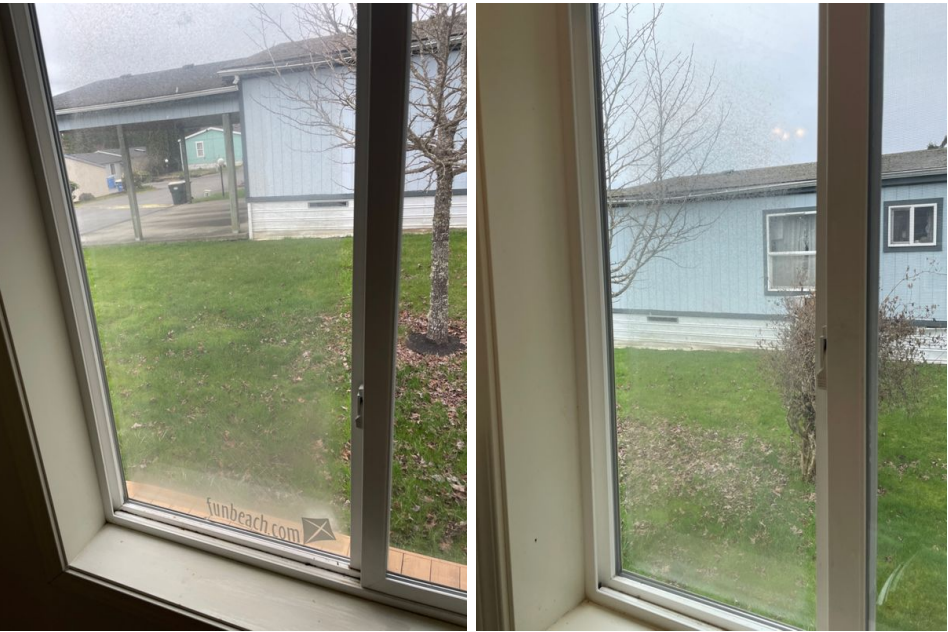
4.2.1 Windows

FOGGED / BROKEN SEALS

I observed more than one fogged windows and broken seals that caused condensation between window panes.

Contact a qualified window repair/installation contractor.

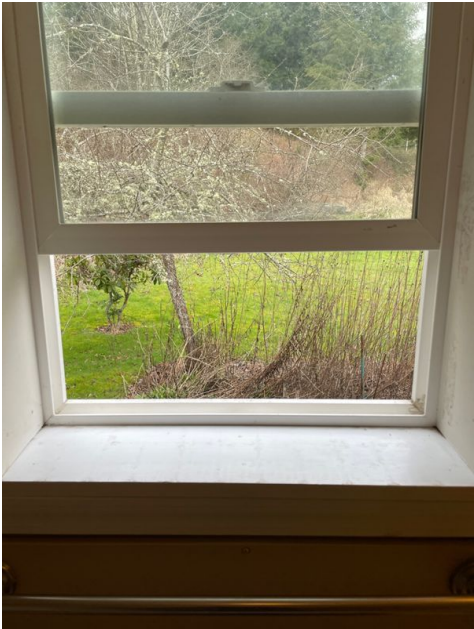
4.2.2 Windows

MISSING WINDOW SCREEN

I observed a missing window screen.

Recommendation
Contact a qualified window repair/installation contractor.

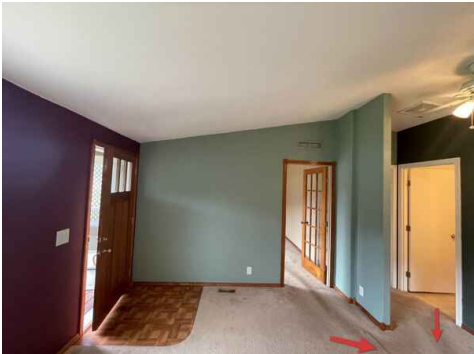
4.3.2 Floors

SEVERE WEAR

LIVING ROOM

Carpet in living room had several areas of bunching, indicating it is no longer properly secured to the floor and creating the a trip hazard.

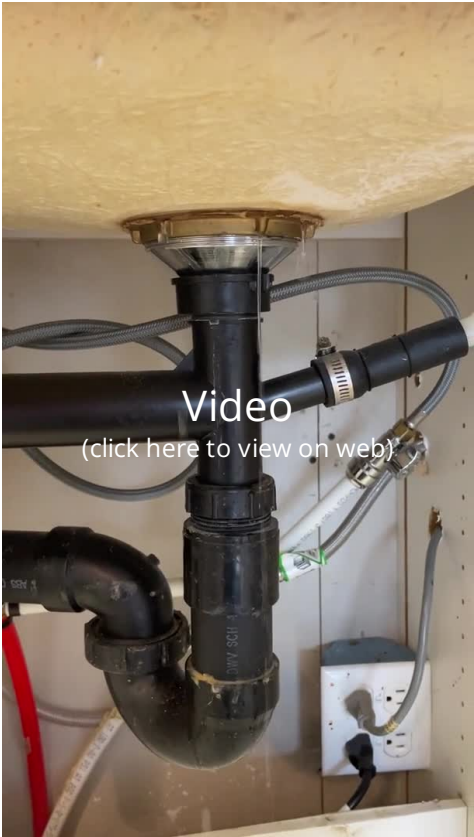
5.1.1 Kitchen Sink
LEAK AT KITCHEN SINK
A significant leak was detected in the drain on the right hand basin of the kitchen sink.
Recommendation
Contact a qualified plumbing contractor.

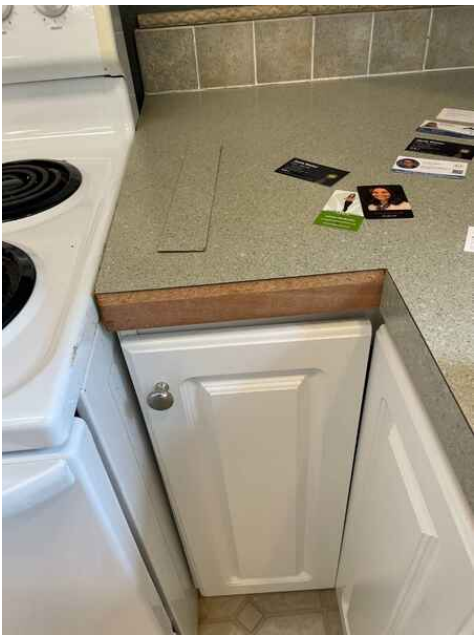
5.8.1 Countertops & Cabinets
COUNTERTOP DAMAGED
I observed damage at the countertop. The missing piece appeared to be sitting on the counter. Recommend attempting to reattach missing piece.
Recommendation
Contact a handyman or DIY project

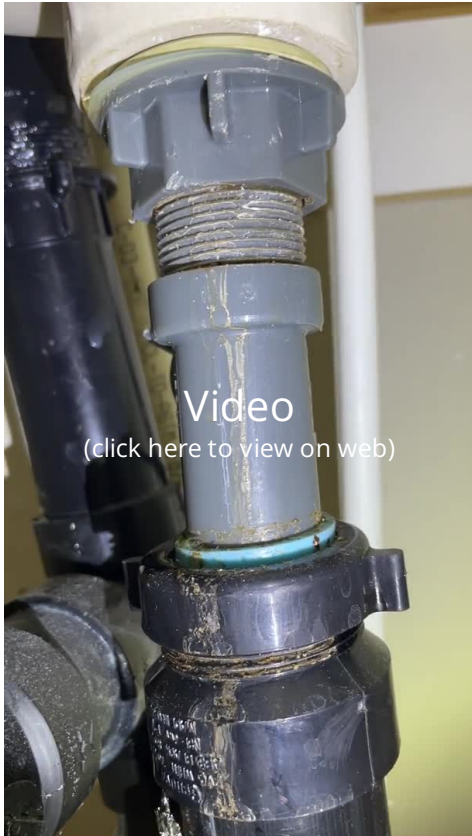
6.4.1 Sinks, Tubs & Showers

ACTIVE WATER LEAK

HALLWAY BATH

I observed an active leak in one or more bathroom sink drains

Contact a qualified plumbing contractor.

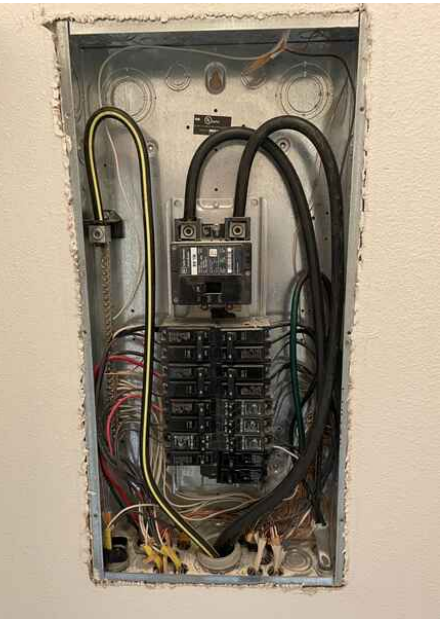
| Main & Subpanels, Service & Grounding, Main Overcurrent Device: Panel Manufacturer Cutler Hammer | Main & Subpanels, Service & Grounding, Main Overcurrent Device: Panel Type Circuit Breaker | Main & Subpanels, Service & Grounding, Main Overcurrent Device: Sub Panel Location Garage |
| Main & Subpanels, Service & Grounding, Main Overcurrent Device: Main panel present Master Closet | Branch Wiring Circuits, Breakers & Fuses: Branch Wire 15 and 20 AMP Copper | Branch Wiring Circuits, Breakers & Fuses: Wiring Method Romex |

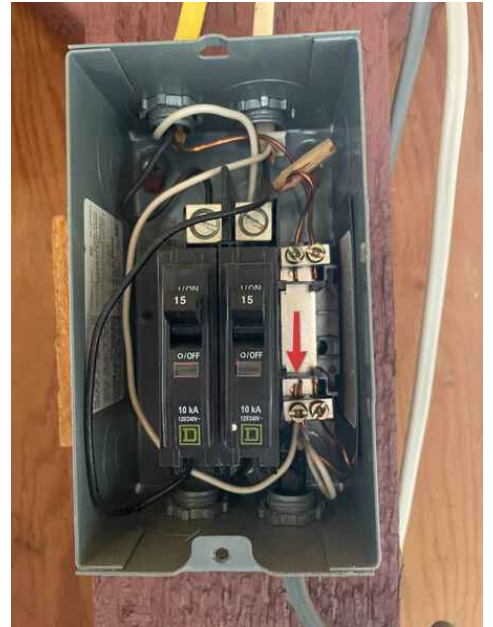
9.2.1 Main & Subpanels, Service & Grounding, Main Overcurrent Device

"DOUBLE TAPPED" NEUTRAL WIRE

One or more neutral wires in the sub panel in the garage have been "double tapped". This is when multiple wires are placed inside the same lug. In most cases each neutral wire should have its own lug space, and double tapping is not typically up to code. Recommend assessment by qualified electrical contractor to determine if correction is needed.

Contact a qualified electrical contractor.

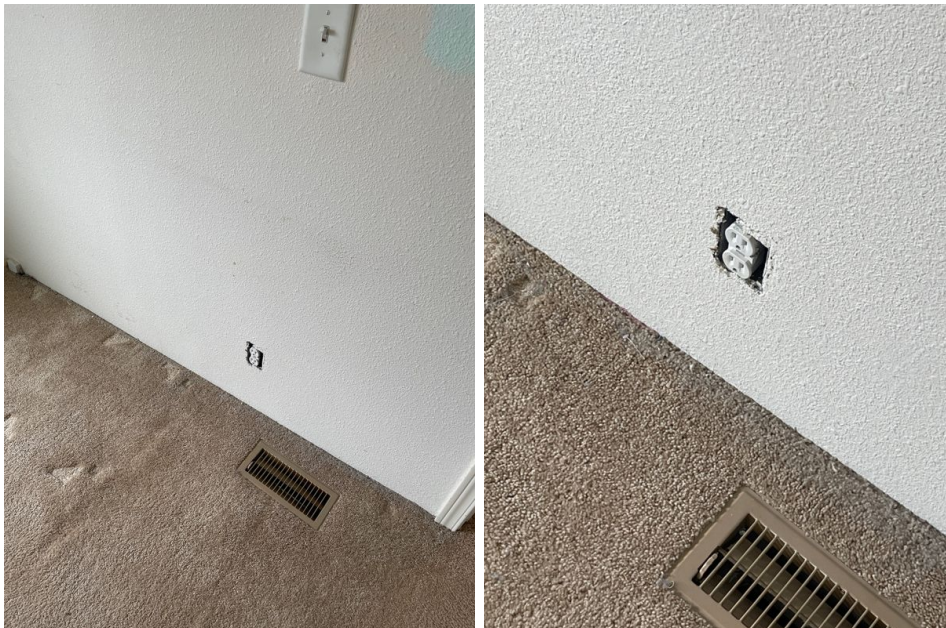
9.4.1 Lighting Fixtures, Switches & Receptacles

COVER PLATES MISSING

One or more receptacles are missing a cover plate. This causes short and shock risk. Recommend installation of plates.

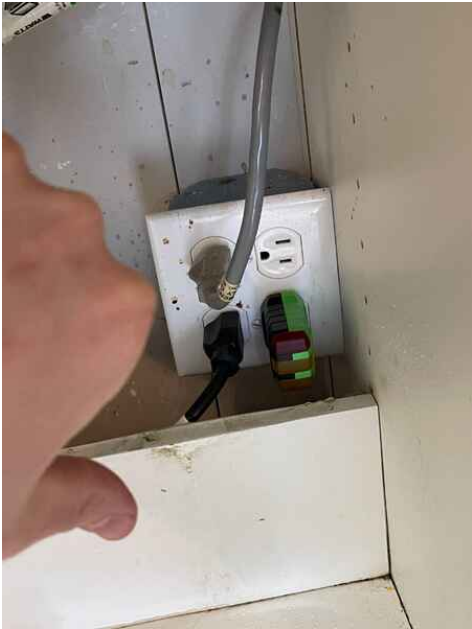
9.4.2 Lighting Fixtures, Switches & Receptacles

OUTLET INOPERABLE

UNDER KITCHEN SINK

One or more outlets did not appear to be receiving power.

Contact a qualified professional.
